Forensic Engineering and Visualization

July 20, 2020

RE: *Crash Reconstruction for Sines v. Kessler*

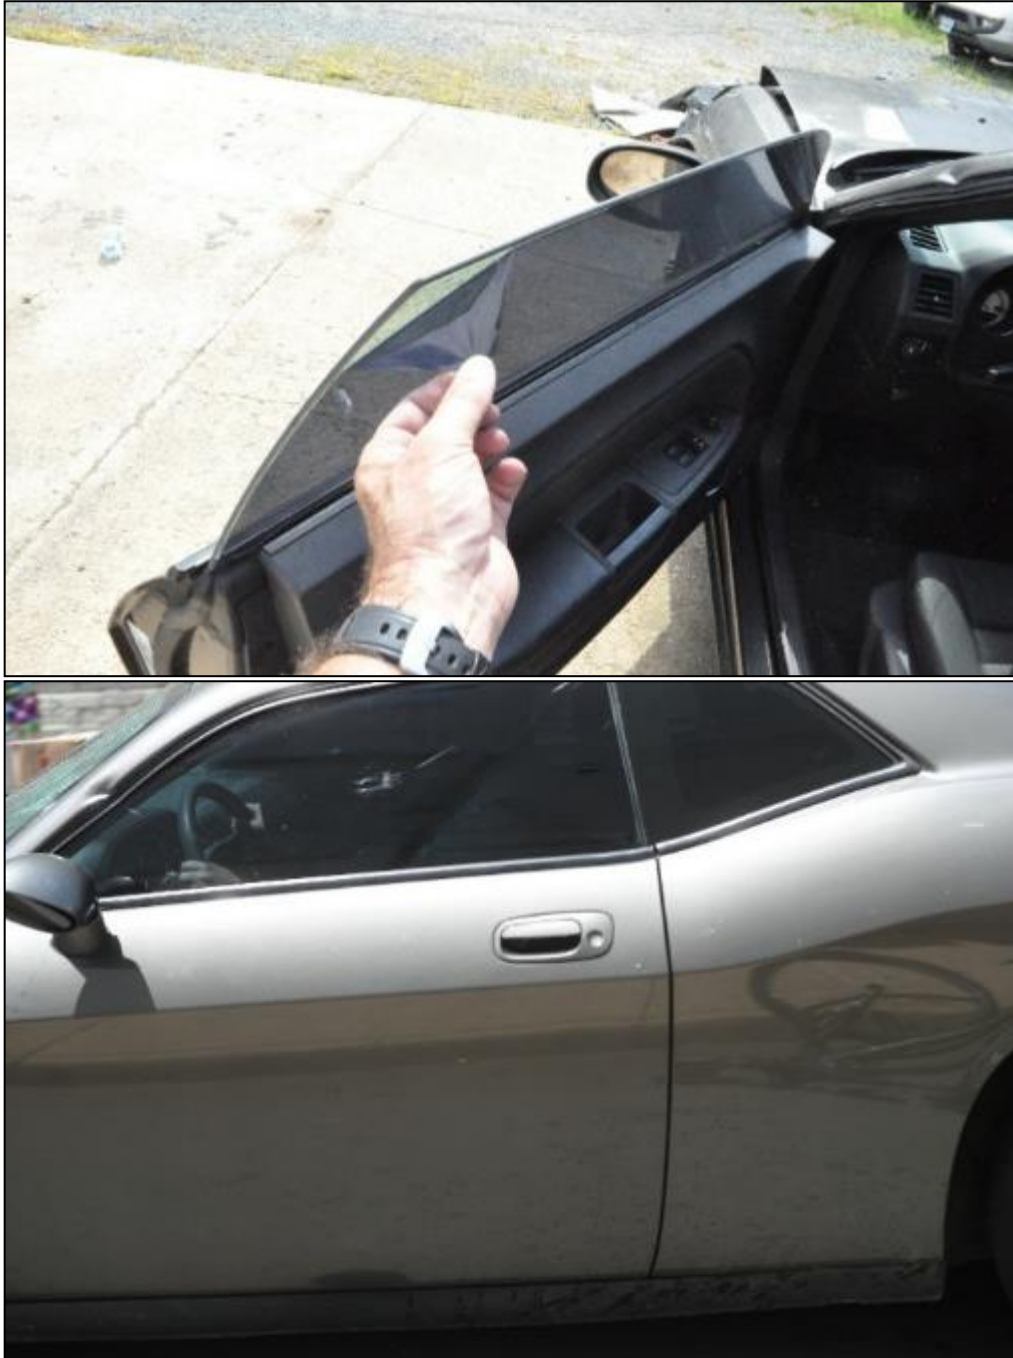
It was determined during the inspection that the driver and passenger side windows were tinted. As seen in the bottom photograph below taken at the time of the crash, the tinting made it difficult to see inside the Challenger.

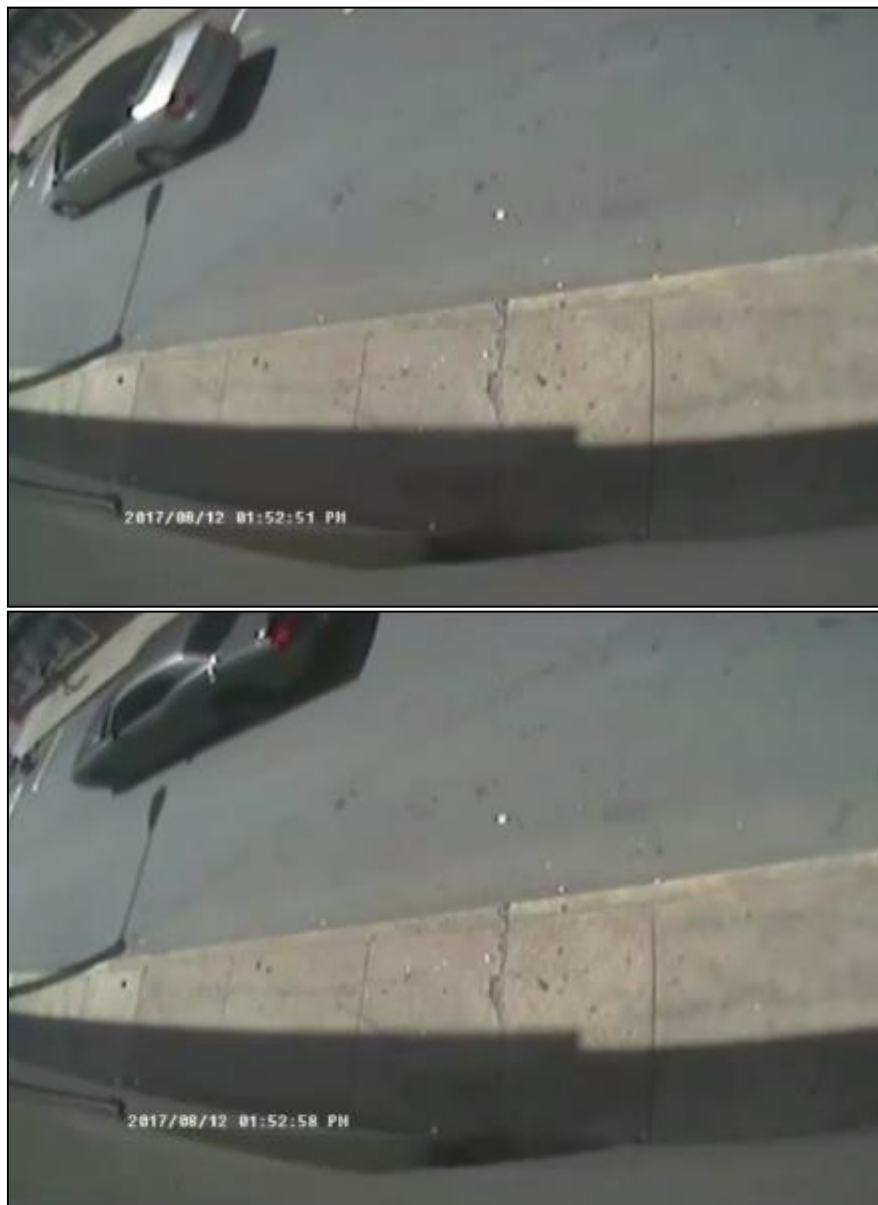
- a. The Red Pump video shows the Challenger followed the Camry down Fourth Street at approximately 1:52 p.m. (time not adjusted to the time in the CFS Report).

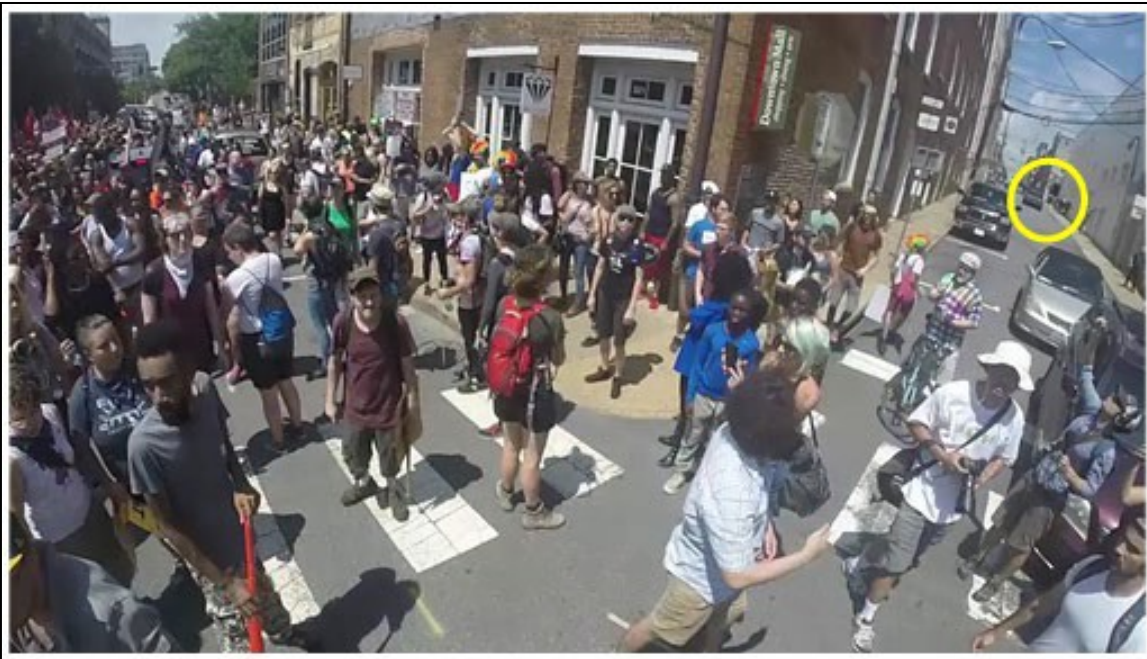
- b. The Challenger crossed Main Street and stopped just south of several newspaper boxes seen on the east side of Fourth Street.

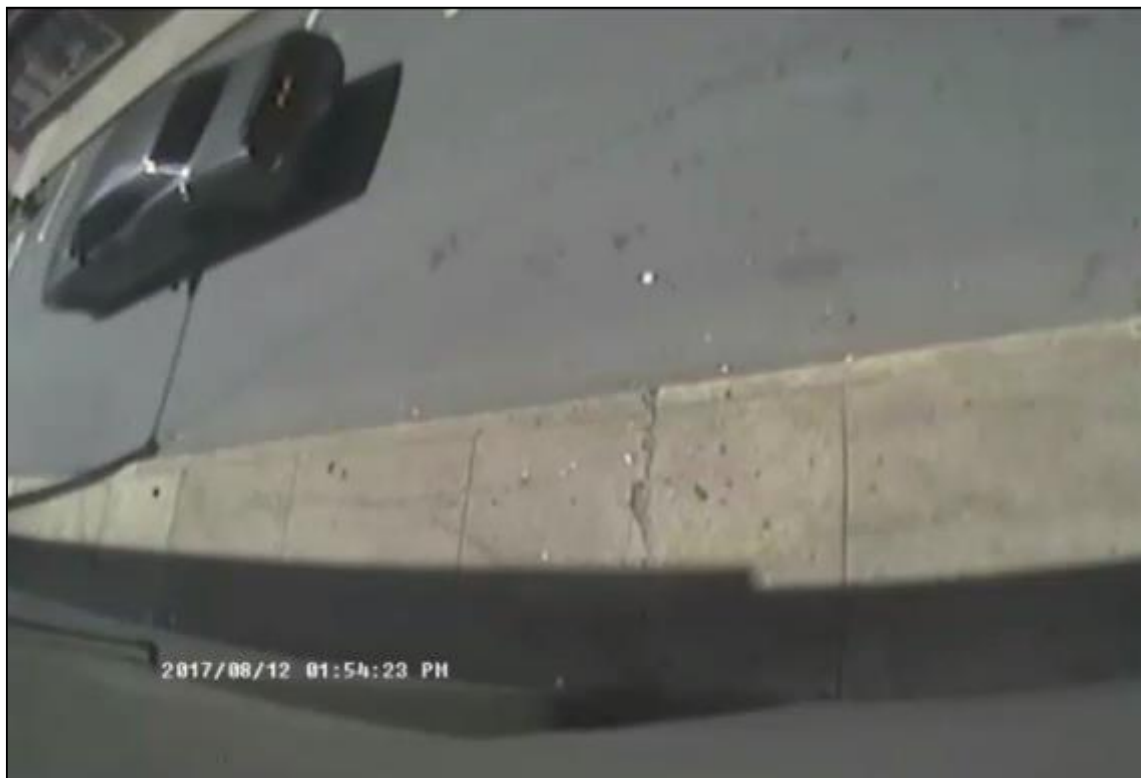
- c. The Challenger then backed up Fourth Street towards Market Street and was visible a second time in the Red Pump video at about 1:54:23 p.m.

- d. **Alternative Routes:** When Mr. Fields was slowly backing up Fourth Street towards Market Street before the crash, he could have continued backing up and exited on Market Street, as he later did after the crash.

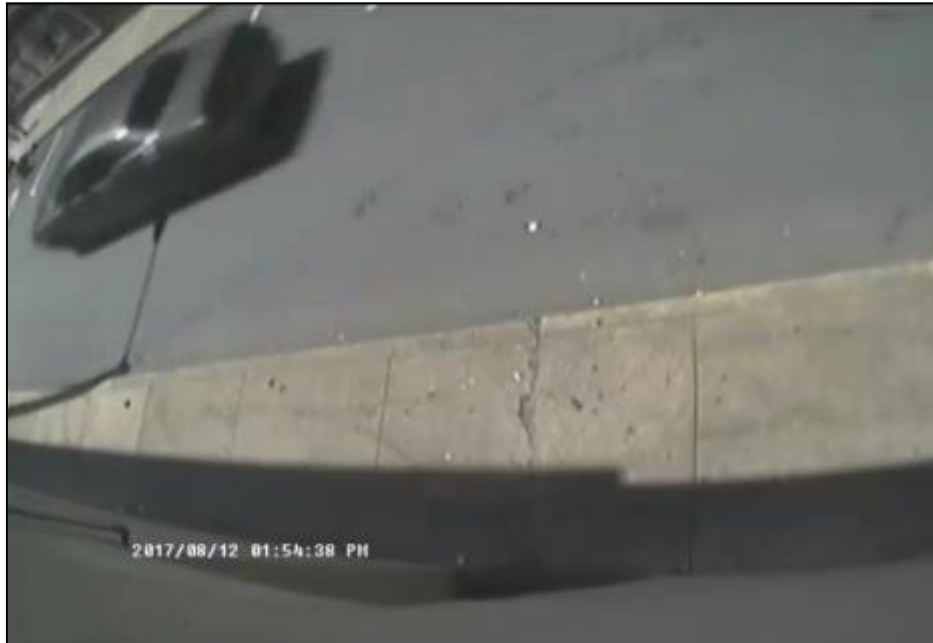
- d. The Challenger was seen a third time in the Red Pump video driving down Fourth Street towards Main Street at a high rate of speed moments later at 1:54:38 p.m.

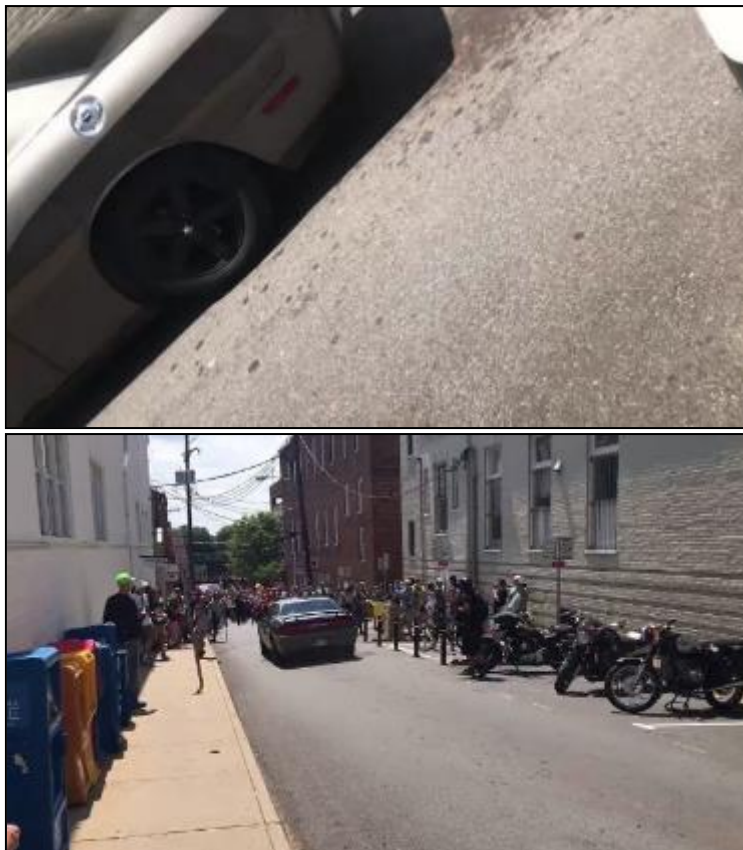
- e. The Challenger is seen crossing Main Street traveling at a high rate of speed and continues past several bollards (black posts) on the west side of the street.

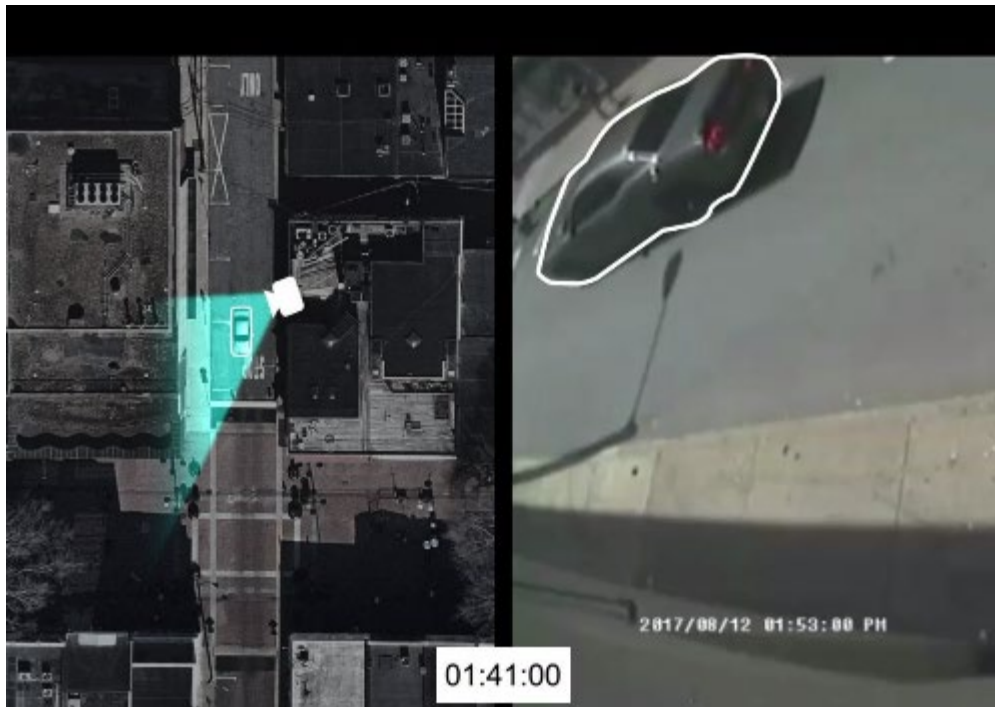
Dodge Visible in the Red Pump video north of the pedestrian mall, driving south toward the mall

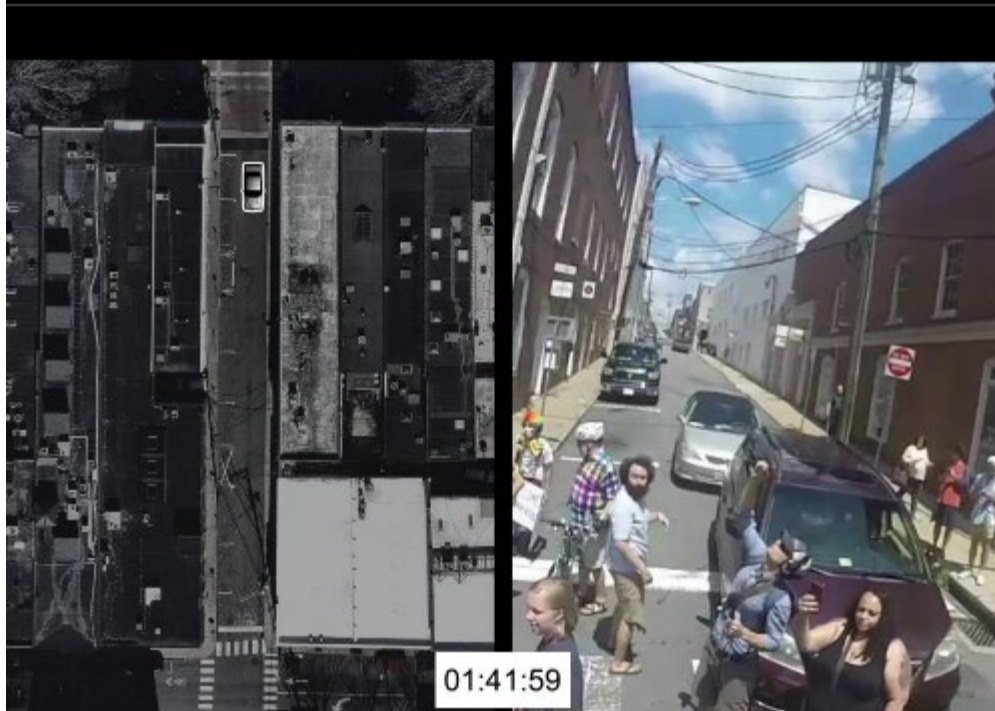
Dodge Visible in the video south of the pedestrian mall sitting at top of hill

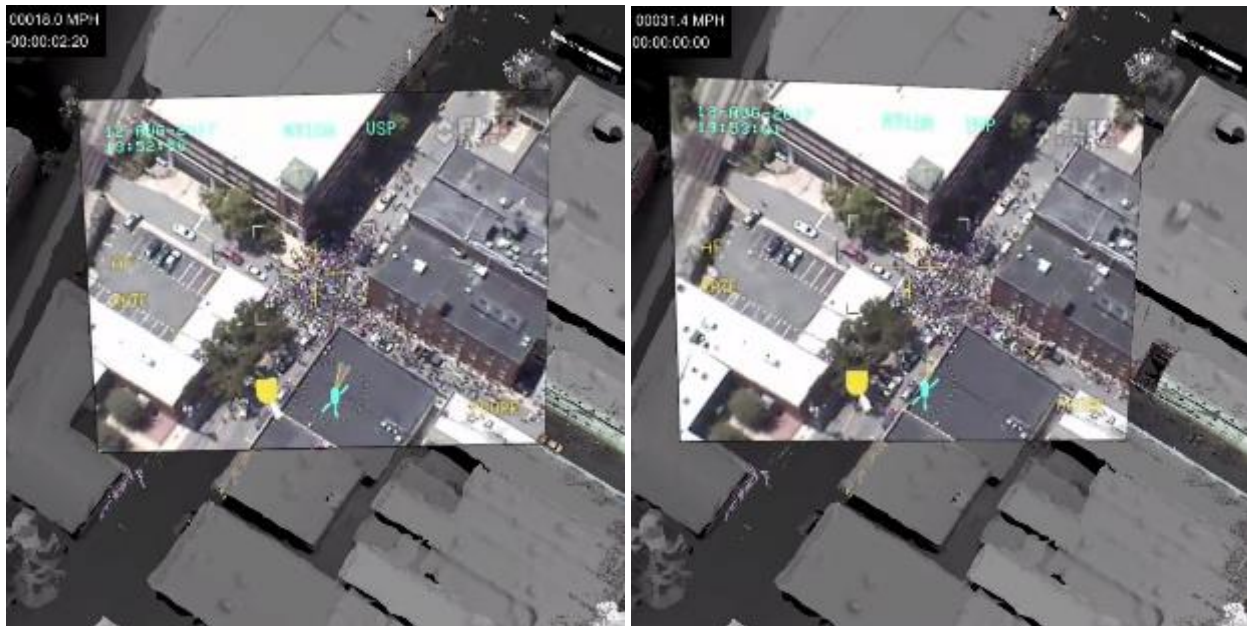
1. As the Challenger enters the video at approximately 1:54:38 p.m. (Red Pump video time), the Challenger travels approximately 20 feet over 12 frames, which equates to 34 mph.

2. The Challenger is shown speeding up and it travels approximately 24 feet over the next 12 frames, which equates to 41 mph.
- ii. Speed in Main Street Video:
  1. The Challenger hits the speed bump south of Main Street, heading for the bollards and brakes. In the video, the Challenger travels approximately 16 feet in 11 frames which equates to 30 mph.
- iii. Speed in helicopter video:
  1. The Challenger enters the video traveling approximately 18 mph and speeds up to approximately 31 mph at impact with the Camry. These speeds were determined using the stabilized video. The first frame below shows the Challenger entering the frame at 18 mph. The second frame shows the Challenger traveling 31.4 mph at impact. The video accompanies this report.

- a. **Speed:** It was determined through photo and video analysis that Mr. Fields accelerated at nearly full throttle from 13 mph to more than 31 mph at impact with the Camry. Had he not accelerated, the pedestrians would have had more time to move out of the Challenger's path.

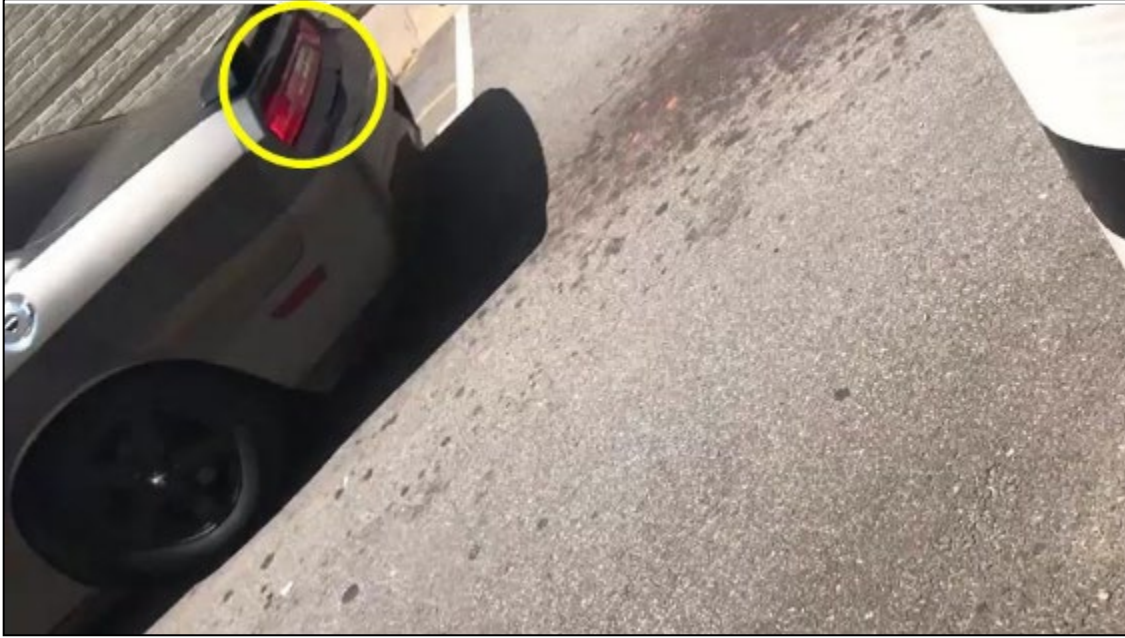
- b. The Challenger's brake lights were analyzed as it traveled down Fourth Street:
  - i. The Challenger's brake lights were illuminated when it came off the speed bump south of Main Street as it headed towards the bollards that surround the bicycle parking area.

- b. **Braking:** After the Challenger came off the speed bump south of Main Street and headed toward the bollards protecting the bicycle rack, Mr. Fields applied the brakes, slowing the Challenger down to approximately 13 mph. Had Mr. Fields continued applying the brakes, he could have stopped in less than ten feet, well short of the pedestrians that were impacted.

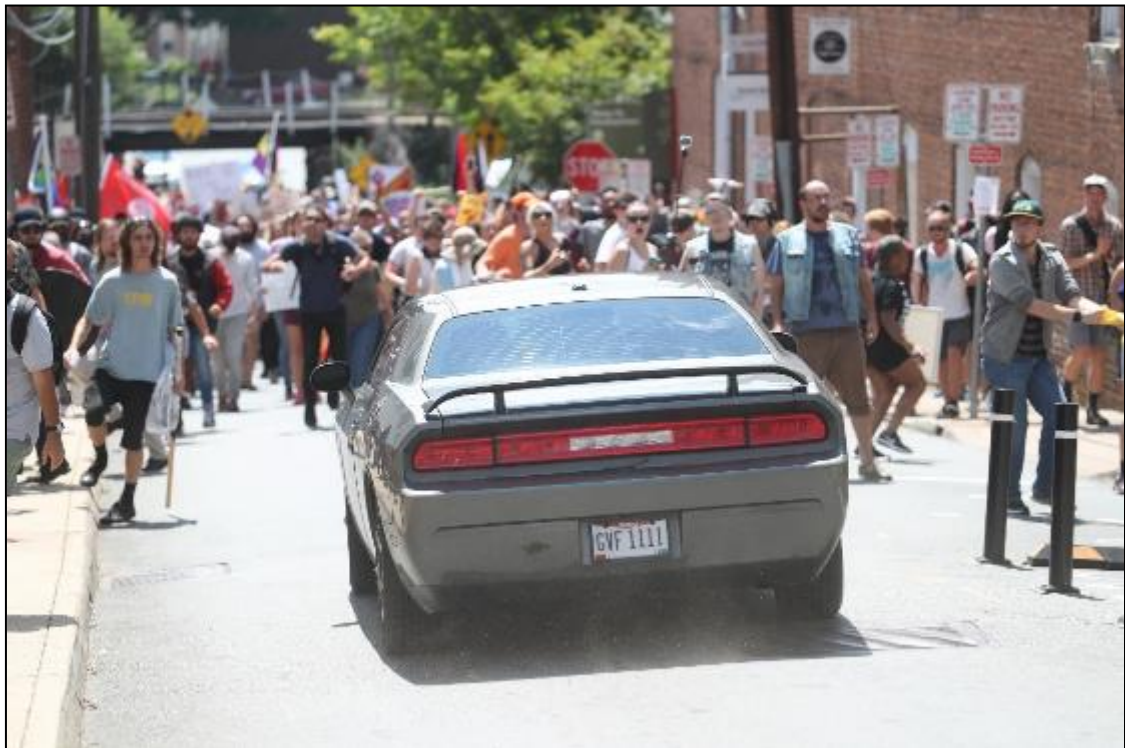
- ii. The Challenger's brake lights went off when the Challenger cleared the bicycle parking area and remained off as it accelerated and traveled up to impact with the Camry.

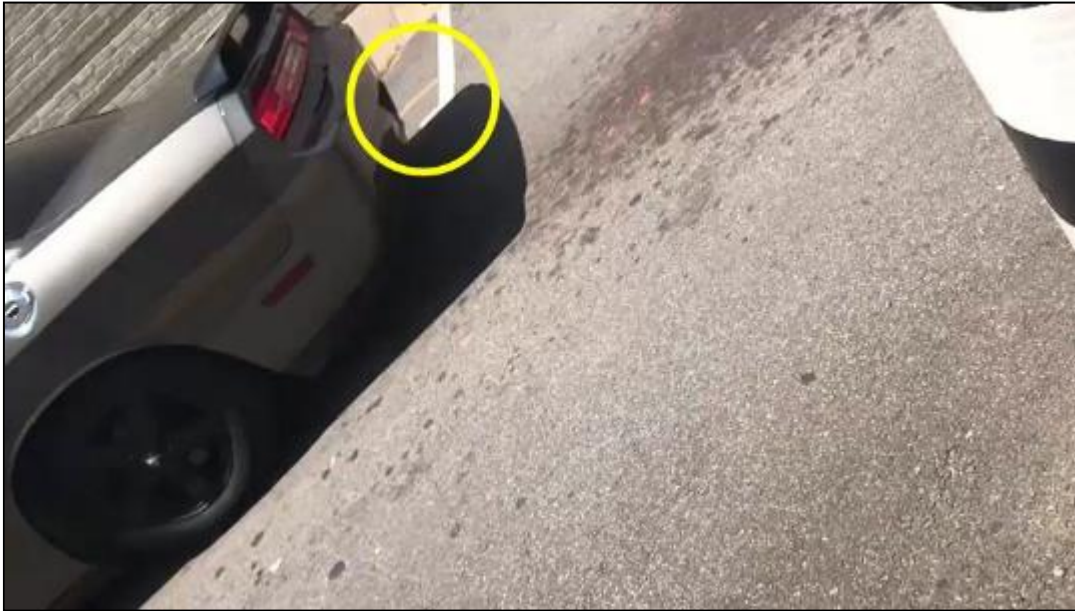
- i. As the Challenger came off the speed bump south of Main Street, it was headed towards the bollards that surrounded the bicycle area. The right side of the Challenger is seen up against the white lines that designate the parking spots on the west side of Fourth Street.

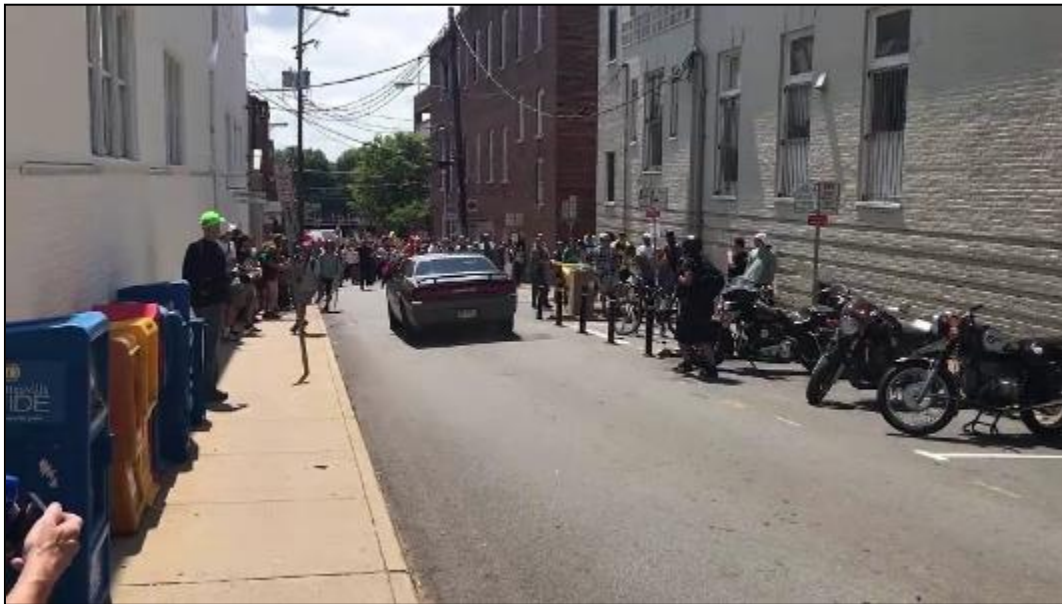
- ii. The Challenger was then steered to the left to avoid the bollards surrounding the bicycle parking area.

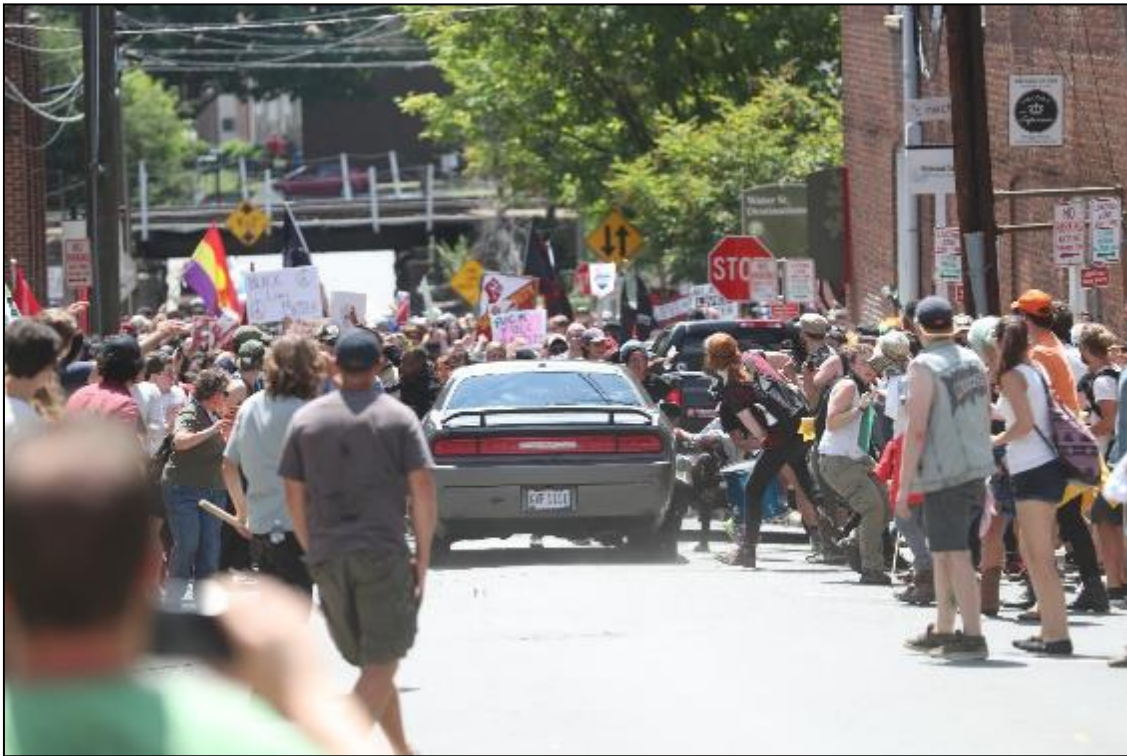
- iii. The Challenger was then steered to the right towards the pickup truck parked on the west side of Fourth Street.

- c. **Steering:** As Mr. Fields passed the bollards, pedestrians jumped out of the Challenger's path towards the sidewalk on both sides of Fourth Street. Several pedestrians were walking adjacent to the pickup truck on the west side of the street and were not able to get to the sidewalk. Mr. Fields steered to the right, towards these pedestrians who did not have an escape route. Had Mr. Fields not steered to the right, he would not have impacted these pedestrians.

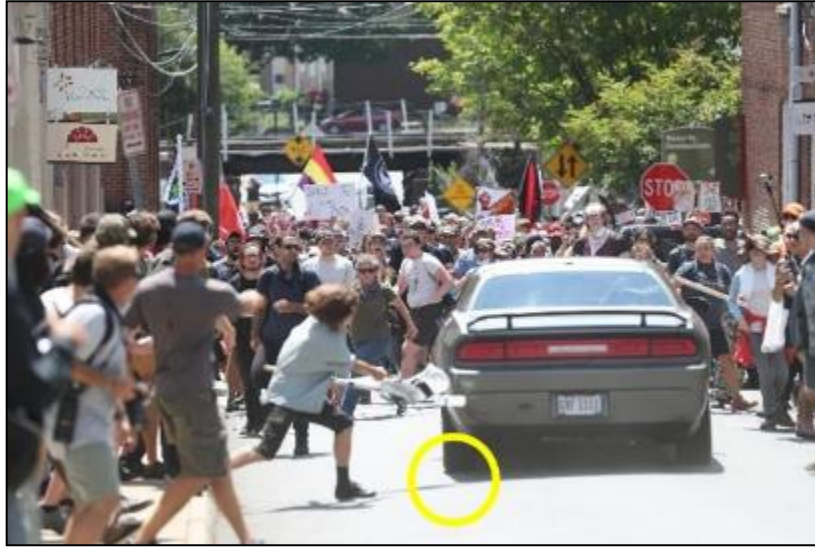
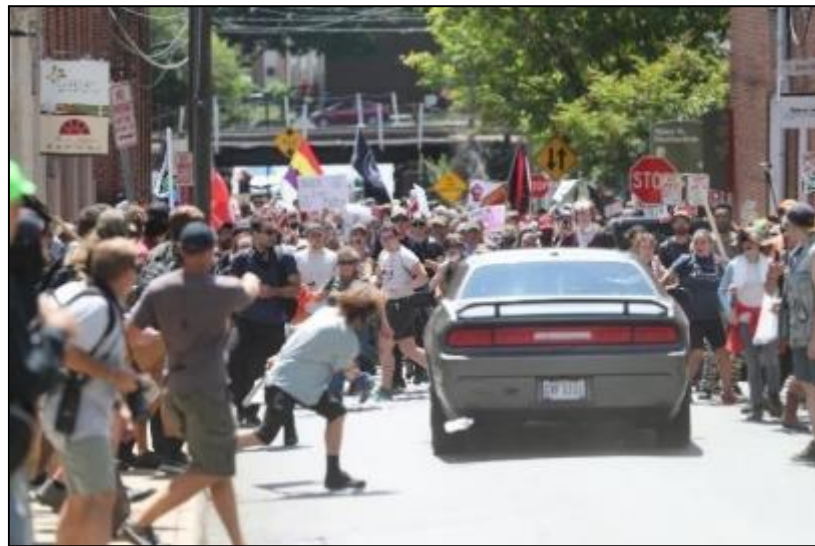
- e. **Pedestrian with Flagpole:** Analysis of the evidence shows that as Mr. Fields was speeding towards the pedestrians, a pedestrian swung a flagpole at the back of the Challenger as it passed him, but he missed and the car was not impacted by the flagpole. Notice that the shadow from the flagpole shows that the pole missed the Challenger. Also, the flagpole's path is not impeded by the Challenger.

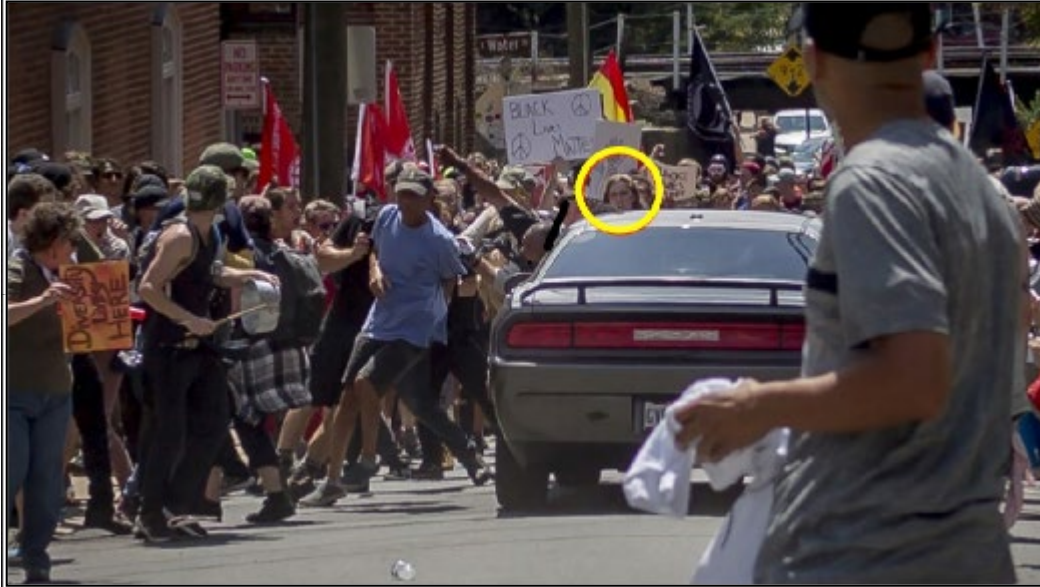
- a. Elizabeth Sines – Ms. Sines was walking north on Fourth Street when she saw the Challenger. She escaped to the east sidewalk when the Challenger was a few feet away from impacting her.

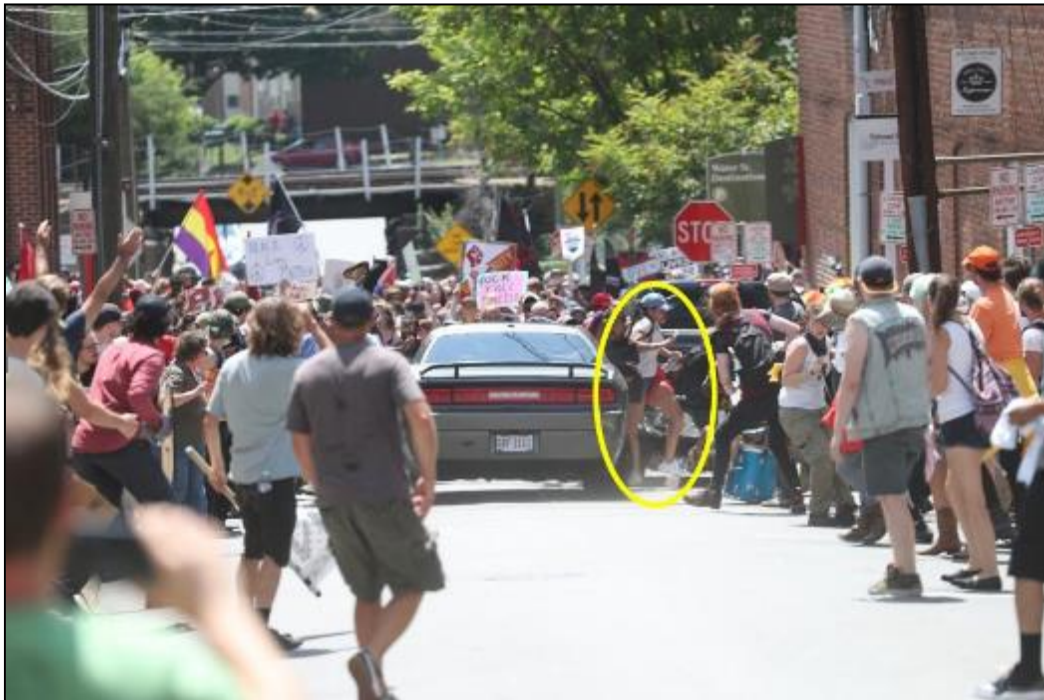
- b. Marissa Blair – Ms. Blair was walking in front of Marcus Martin adjacent to the pickup truck parked on the west side of the street. She was pushed out of the Challenger's path towards the sidewalk by Marcus Martin.

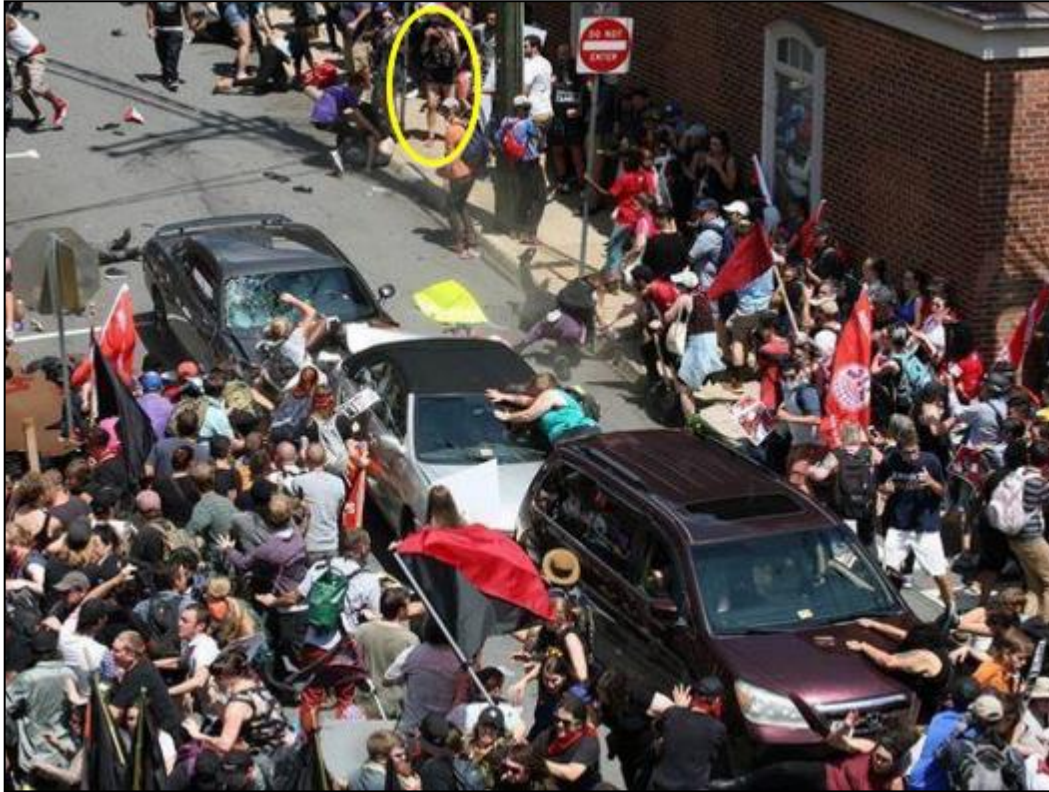
- c. April Muniz – Ms. Muniz was walking on the east side of the street at the time of the crash and is pictured on the east sidewalk as the Challenger impacted the Camry.

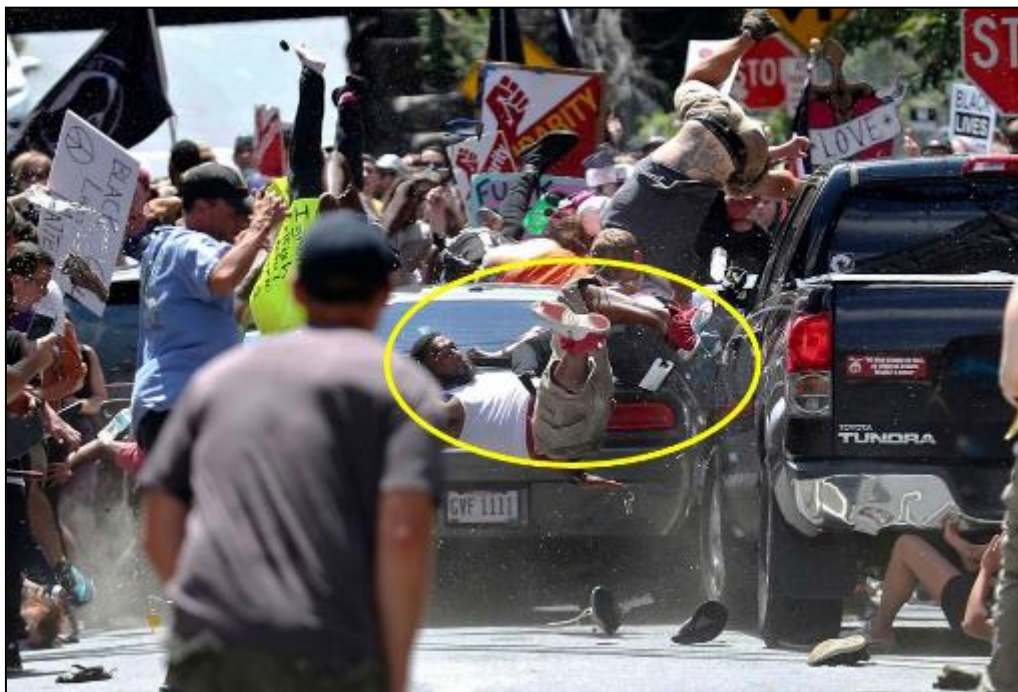
- d. Marcus Martin – Mr. Martin was impacted by the Challenger and went over the top of the Challenger.

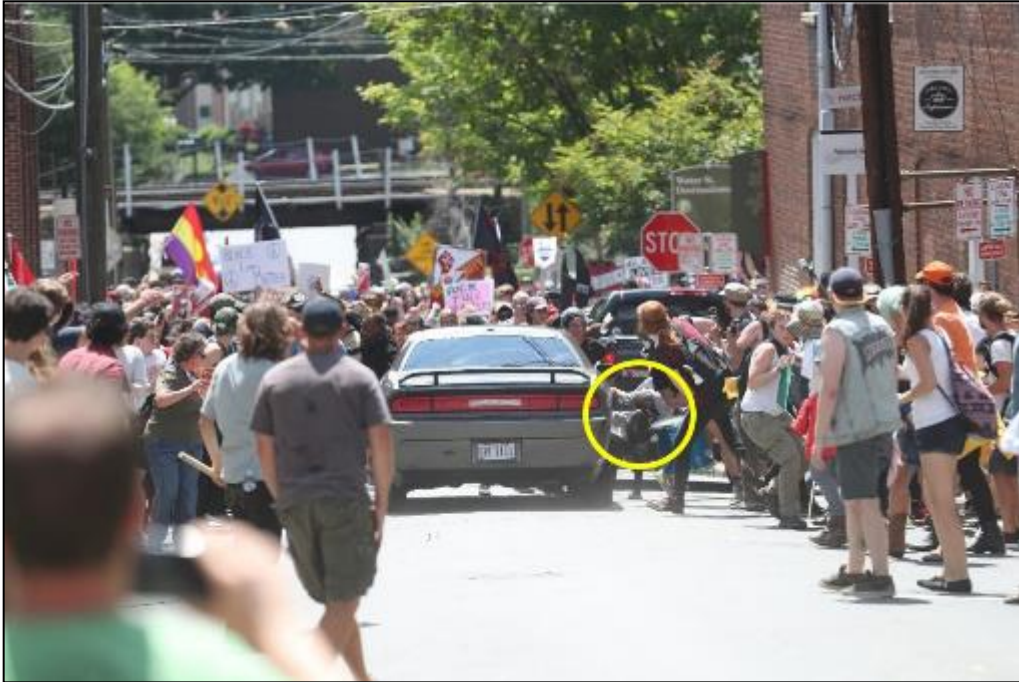
- e. Natalie Romero – Ms. Romero was impacted by the Challenger and was thrown towards the west sidewalk. She is seen upside down in photo below.

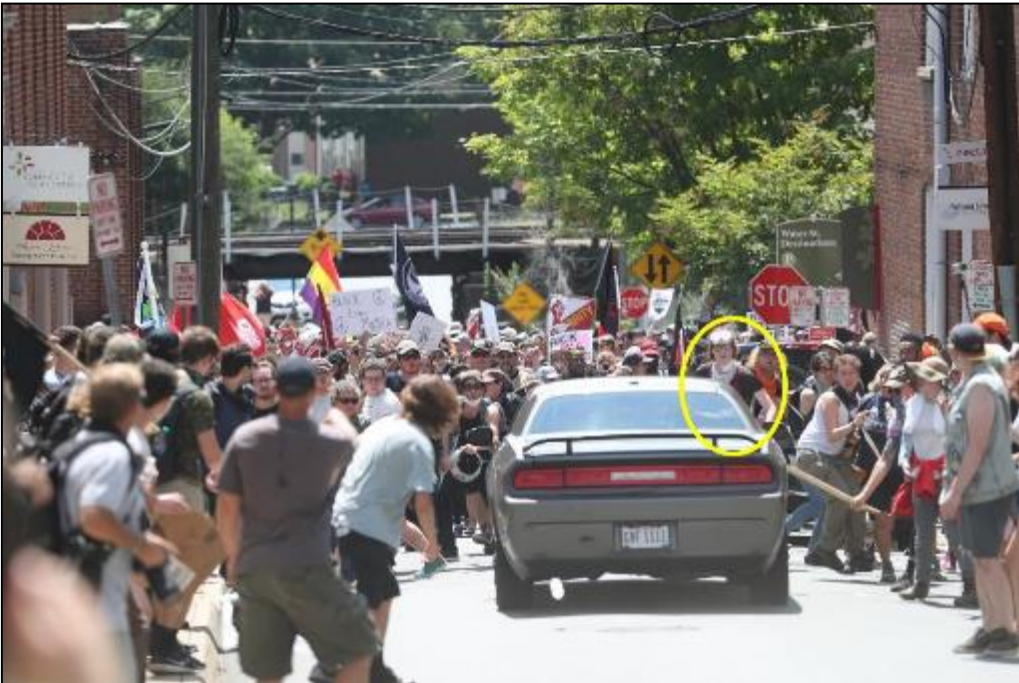
- f. Chelsea Alvarado – Ms. Alvarado was carrying a drum. She and the drum were impacted by the Challenger and thrown to the west.

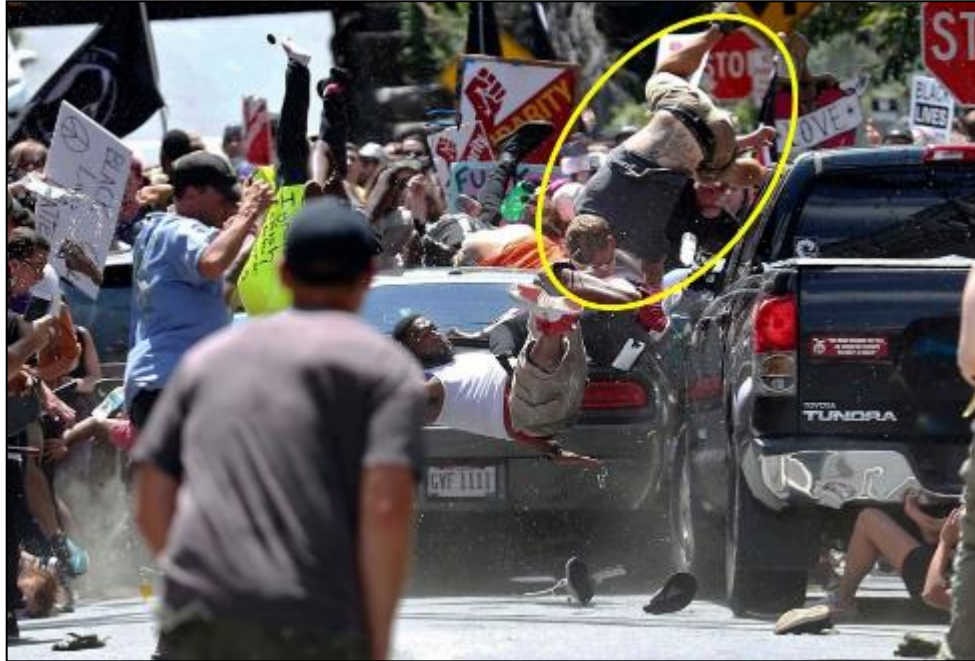
- g. Thomas Baker – Mr. Baker was impacted by the Challenger, and he went over the top of the Challenger.

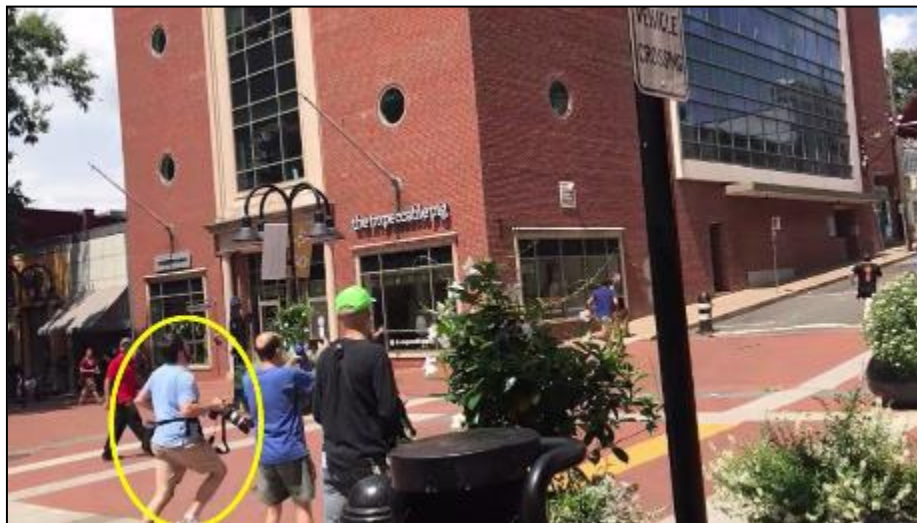
- h. Ryan Kelly – Mr. Kelly was north of the area of the collision and photographed the Challenger as it traveled down Fourth Street and then back up towards Market Street.
